Docket No. 217 – Development and Management Plan Inspection

Northeast Utilities Service Company Certificate of Environmental Compatibility and Public Need for the construction of a 345-kV electric transmission line and reconstruction of an existing 115-kV electric transmission line between Connecticut Light and Power Company's Plumtree Substation in Bethel, through the towns of Redding, Weston, and Wilton, and to the Norwalk Substation in Norwalk, Connecticut.

Date: December 9, 2004

Location: Norwalk Substation Expansion

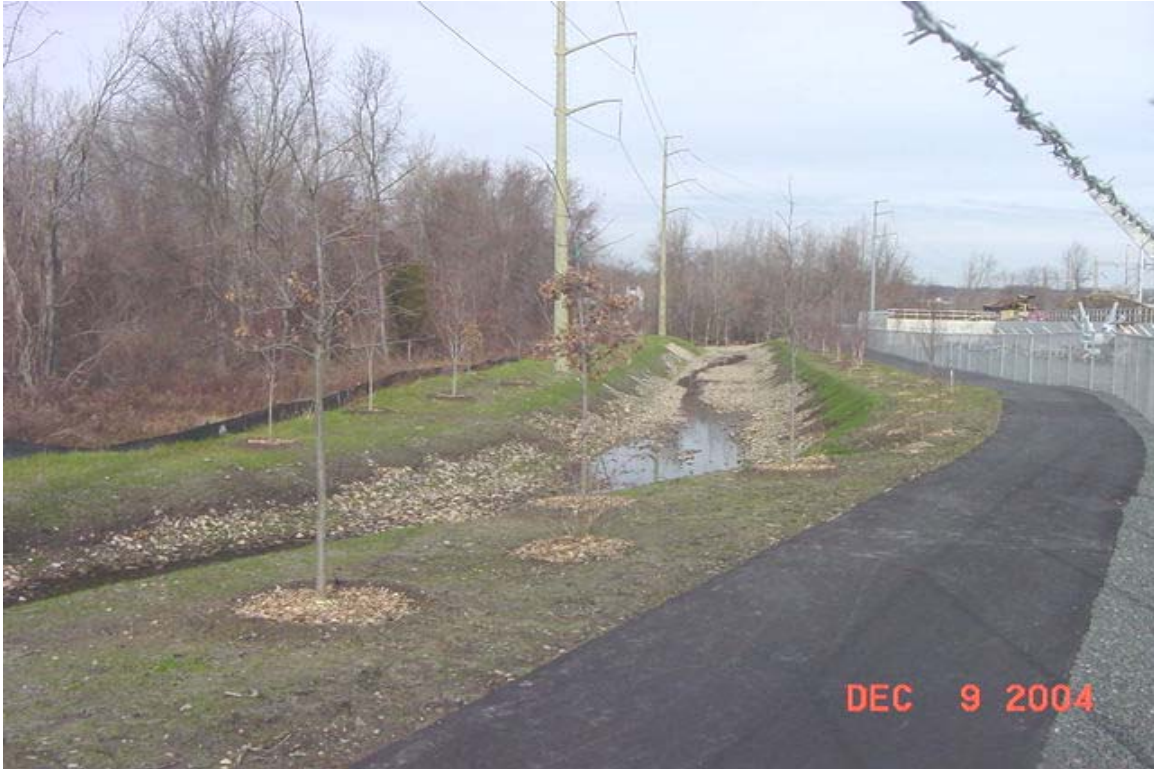
Germination of the hydroseeded areas and the resulting grass growth has slowly continued.
12/09/04

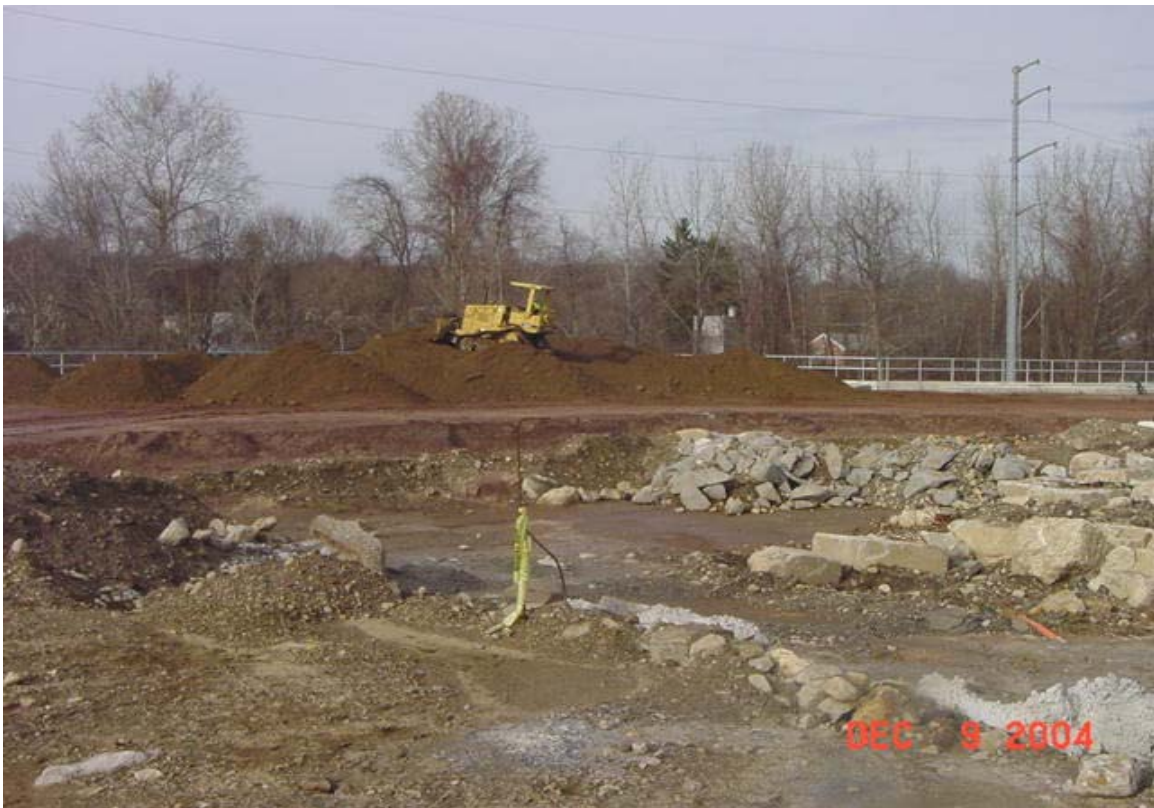
Stockpiling is occurring as a result of the ground grid excavation. All soil is well enclosed within the site. 12/09/04

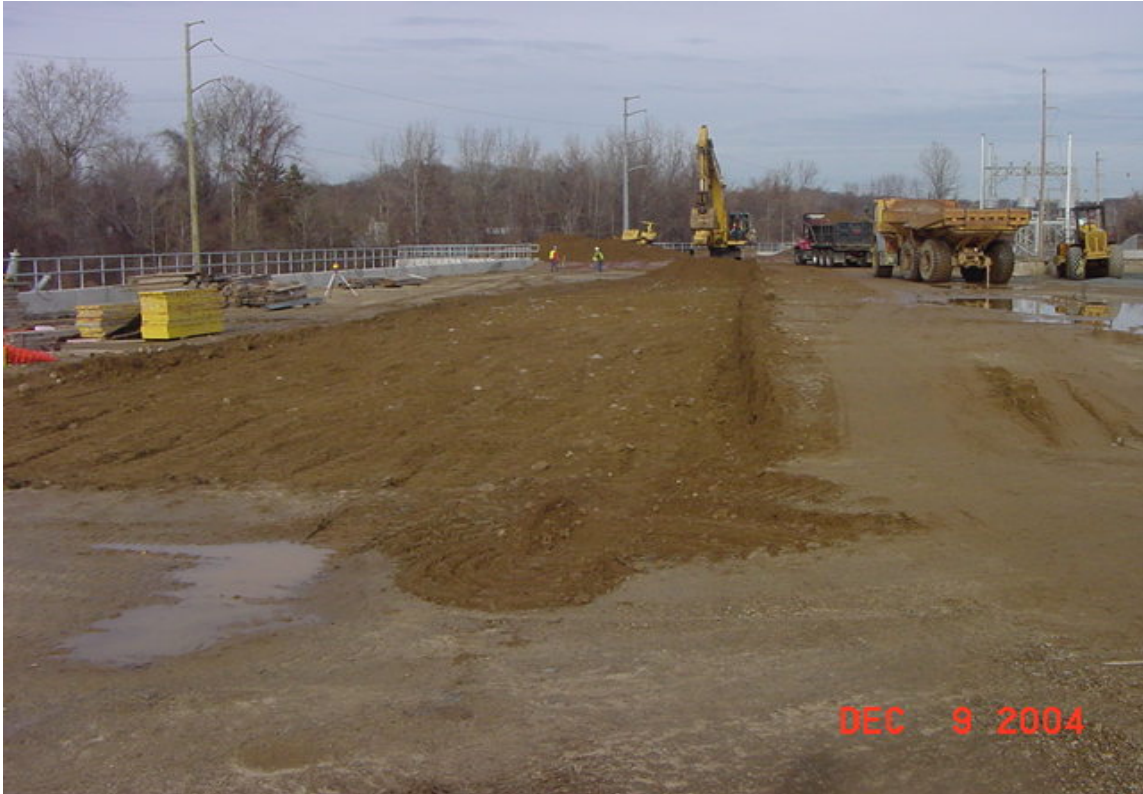
View of the excavation for the grounding grid around the future GIS building. 12/09/04

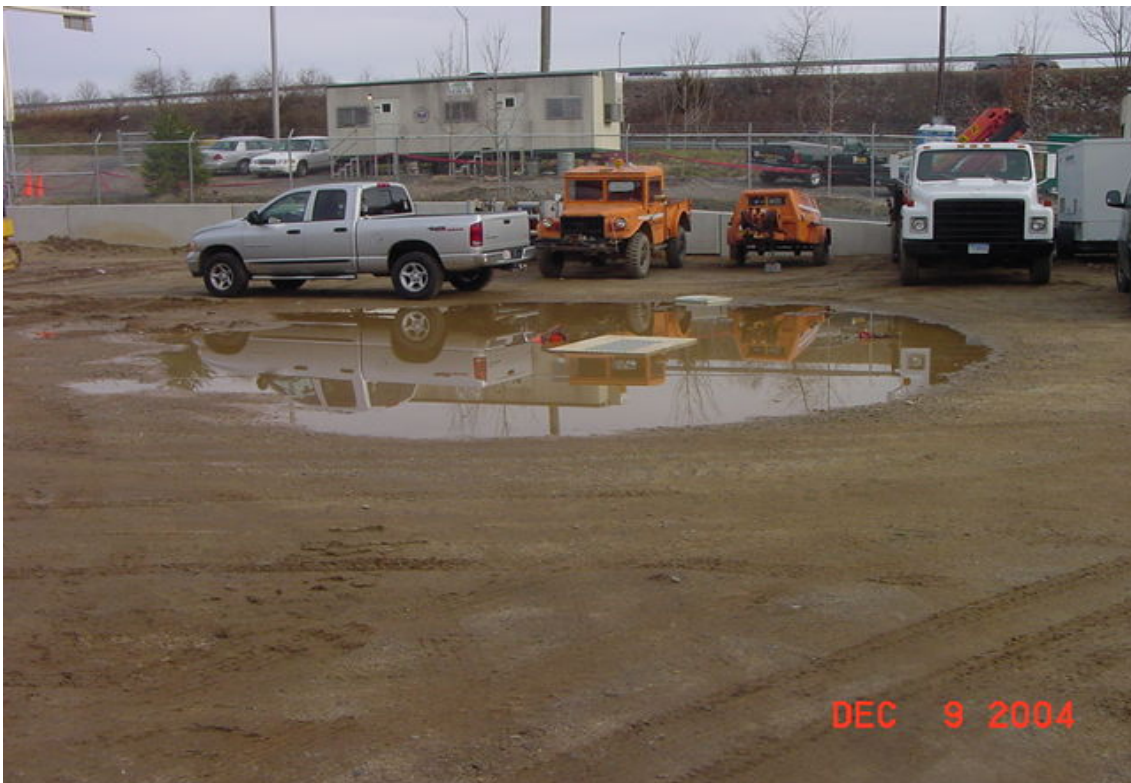
- A catch basin near the small control building has a very large, deep puddle around it. It could not be confirmed visually that there was any filter fabric installed in it. Water does not appear to have entered the basin at this time but additional rains may cause this. 12/09/04	- Confirm sediment controls are on this catch basin in order to prevent silty water from entering the storm water system. 12/09/04
Inland Wetland and Watercourse encroachment and mitigation	- The adjacent wetland areas were in flooded conditions as a result of the rain events. The overflow channel was working very well however. 12/02-12/09/04	-Silt fence will be removed from areas with sufficient cover. Continue to monitor areas 12/02-12/09/04

Rain water is pooling around a catch basin on site. It could not be visually confirmed whether there was filter fabric installed. Fabric should be in place here to reduce silt in the stormwater system. 12/09/04

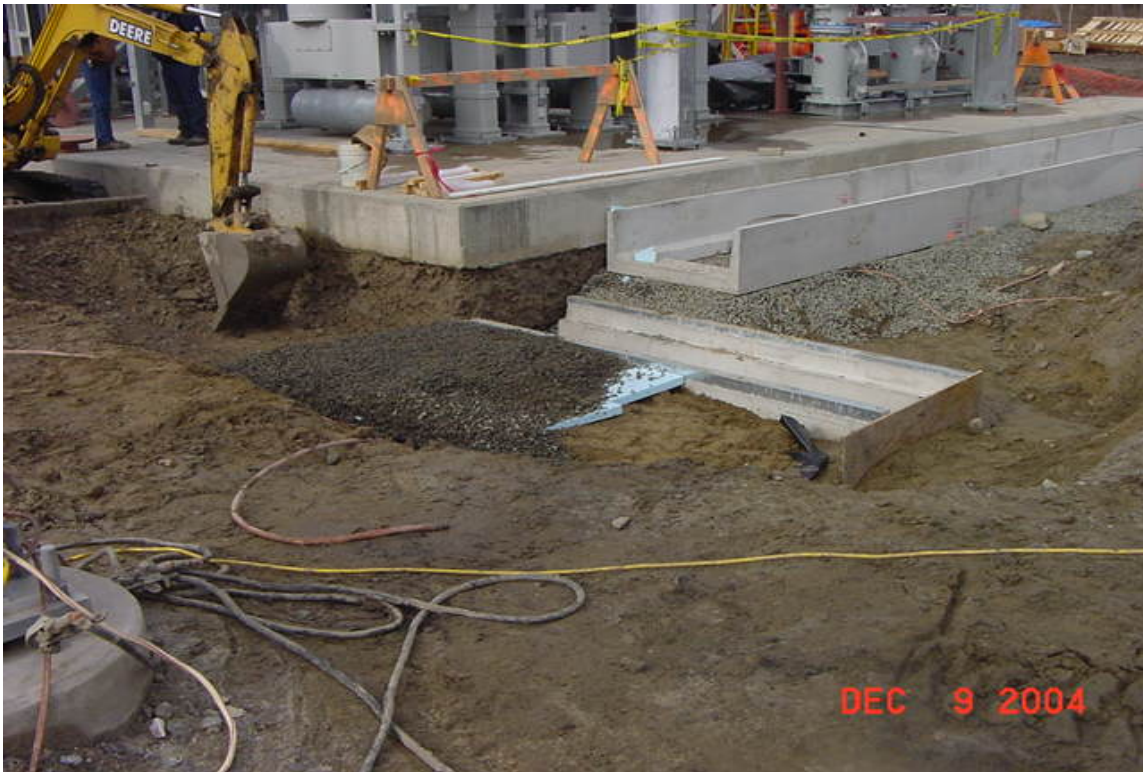
Plumtree Substation: Work continues on minor excavation/installation of cable trenches adjacent to the concrete slab. 12/09/04

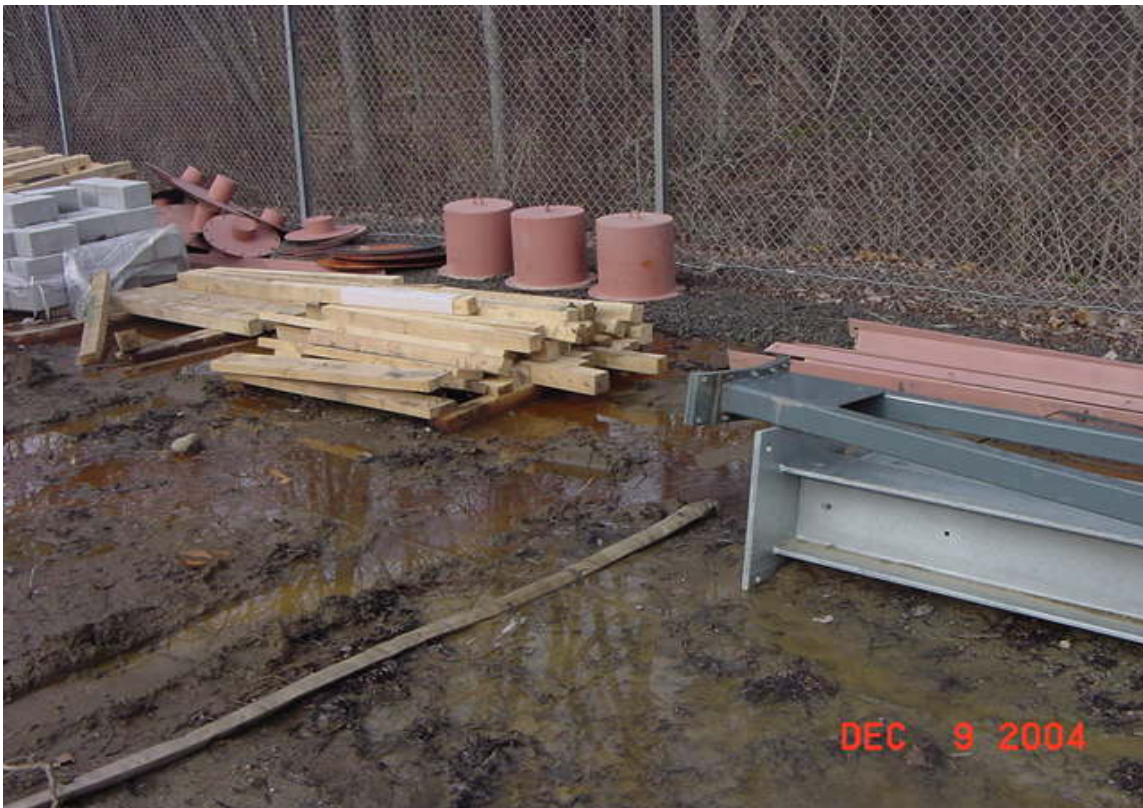
Dewatering	- Some minor dewatering has resumed as a result of the minor excavation near the pad and the rains. The end of the discharge hose is fairly close to the perimeter fence and conditions are muddy here. The berm continues to prevent any overflow but this area should be monitored because	- None at this time.

Some minor dewatering has continued as a result of the recent rains and the excavations. Muddy conditions near the perimeter fence will continue to be monitored. 12/09/04
